[Docket No. FAA-2007-29089; Directorate Identifier 2007-NM-215-AD; Amendment 39-15197; AD 2007-18-52]

Airworthiness Directives; Boeing Model 737-600, -700, -700C, -800, -900, and -900ER Series Airplanes

2007-18-52 Boeing: Amendment 39-15197. Docket No. FAA-2007-29089; Directorate Identifier 2007-NM-215-AD.

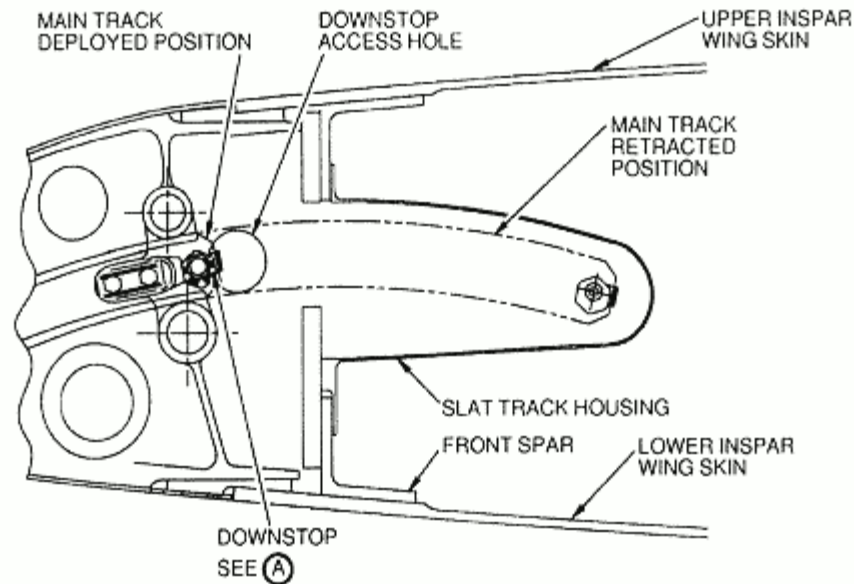
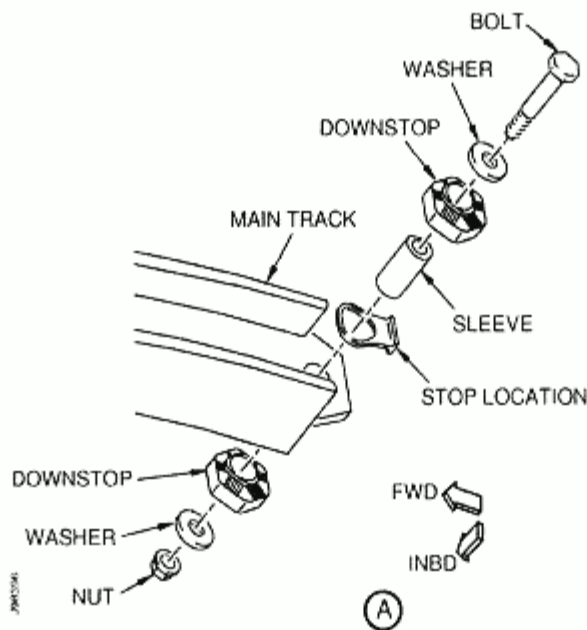
(d) This AD results from additional reports of parts coming off the main slat track downstop assemblies. We are issuing this AD to detect and correct loose or missing parts from the main slat track downstop assemblies, which could result in a fuel leak and consequent fire.

(f) Within 10 days after the effective date of this AD: Do a detailed inspection or a borescope inspection of each main slat track downstop assembly to verify proper installation of the slat track hardware (i.e., the bolt, washers, downstops, stop location, and nut shown in Figure 1 of Boeing Service Letter 737-SL-57-084-B, dated July 10, 2007, and in this AD). Proper installation of the sleeve need not be confirmed, and the stop location part may be installed on either the inboard or the outboard side of the slat track. If any part is missing or is installed improperly, before further flight, install a new or serviceable part using a method approved in accordance with the procedures specified in paragraph (h) of this AD; and do a detailed inspection of the inside of the slat can for foreign

object debris (FOD) and damage. Before further flight, remove any FOD found and repair any damage found using a method approved in accordance with the procedures specified in paragraph (h) of this AD. Using Boeing Multi Operator Message Number 1-523812011-1, issued August 25, 2007; or 1-527463441-1, issued August 28, 2007; is one approved method for verifying proper installation; installing a new or serviceable part; and inspecting for damage and FOD, and removing FOD and repairing damage. Repeat the actions required by paragraph (f) of this AD thereafter at intervals not to exceed 3,000 flight cycles.

(g) Within 24 days after receipt of AD 2007-18-51: Apply a torque between 50 to 80 inch-pounds to the nut. The bolt head must be held with the torque applied to the nut.
